# Manhole Inspection Summary

Manhole # S15GG1017MH

Insp Date: **3/1/07 10:54 AM**

**Location** Address: **4101 ROLAND VIEW AVE**

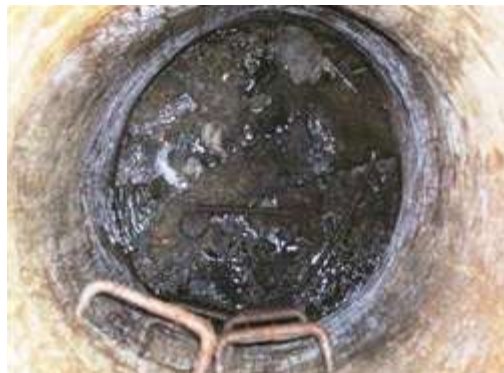
Top View

Corroded steps. Evidence of surcharge - Bench debris. Channel debris.

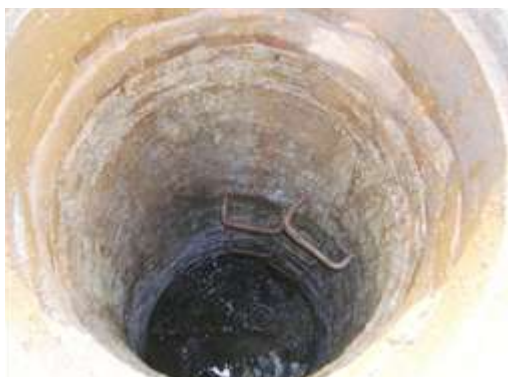
Defect

Frame leaks. Adjustment deterioration and infiltration. Corbel and Barrel infiltration - other side.

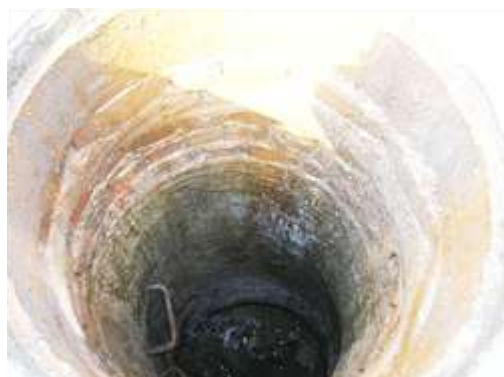
Defect

Frame leaks. Adjustment deterioration and infiltration. Corbel and Barrel infiltration.

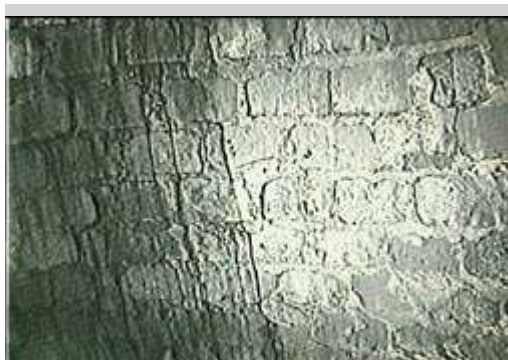
Defect

Barrel deterioration and infiltration.

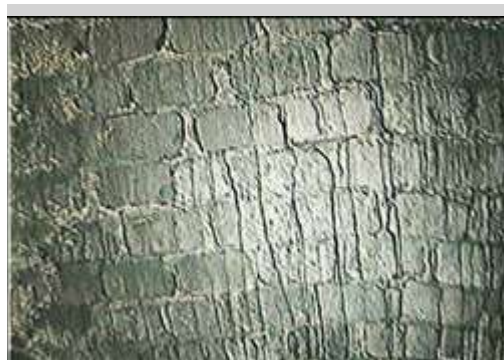
Defect

Comments **Active dripper in Corbel/Barrel.**

Corbel and Barrel deterioration and infiltration (Dripper).

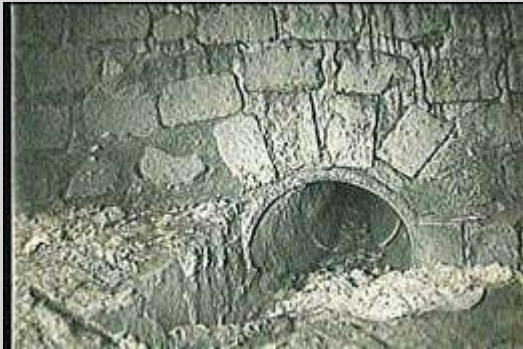
Pipe Out @ 12 O'Clock

Barrel deterioration and infiltration.

Deposits: ☐ None ☐ Mud ☐ Sludge ☒ **Debris** ☒ **Grease**

Silt Depth: **2** (in.) Deposits Extent: **Light**

Infiltration: **Evidence** Pipe Seal Cond: **Unknown**

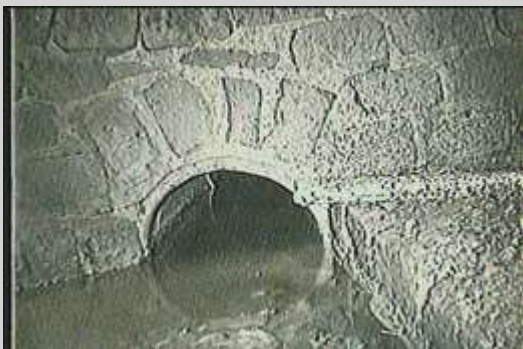
Pipe In @ 3 O'Clock

Deposits: ☐ None ☐ Mud ☐ Sludge ☒ **Debris** ☒ **Grease**

Silt Depth: **0.5** (in.) Deposits Extent: **Light**

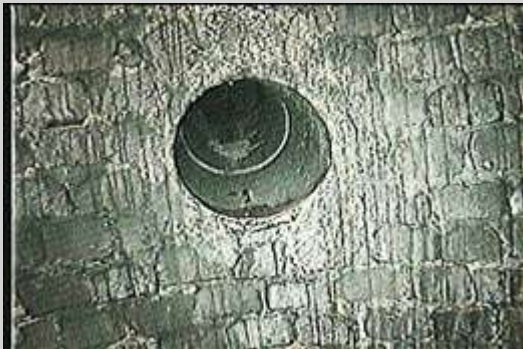
Pipe In @ 8 O'Clock

Deposits: ☐ None ☐ Mud ☐ Sludge ☒ **Debris** ☒ **Grease**

Silt Depth: **5** (in.) Deposits Extent: **Heavy**
